BELOW OPPOSITION COUPLING WAS REPLACED BY THE THOMPSON COUPLING TCAE-4-R SUCCESSFULLY. THIS DEMONSTRATES THE DAMAGE AXIAL MOVEMENT OF STEAM TURBINE CAUSES BUT WHICH THE TCAE RANGE MINIMISES/ELIMINATES.

Machinery Investigation September 2017 – Coupling Failure

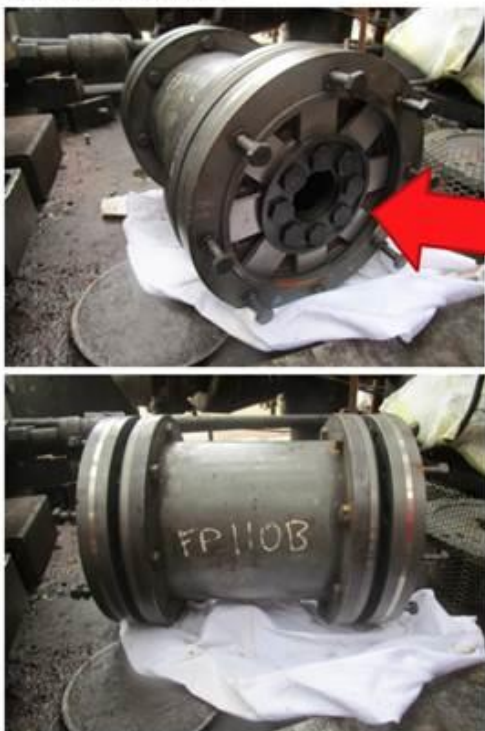
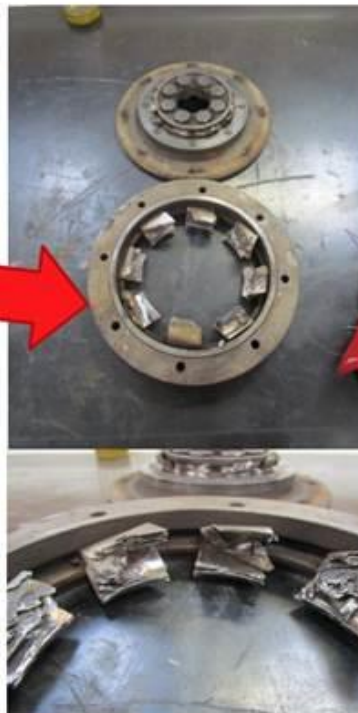
- **September 2017 failure**

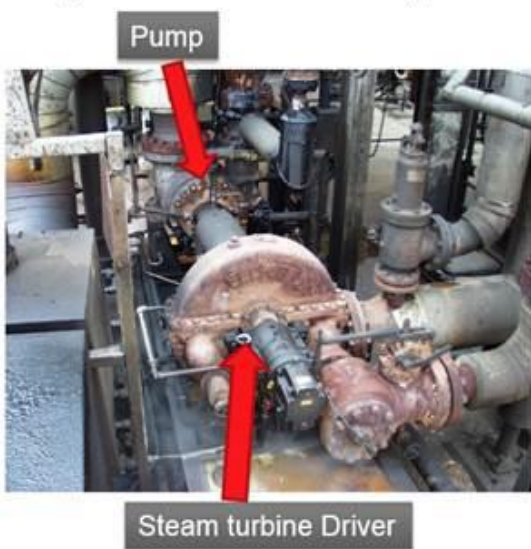
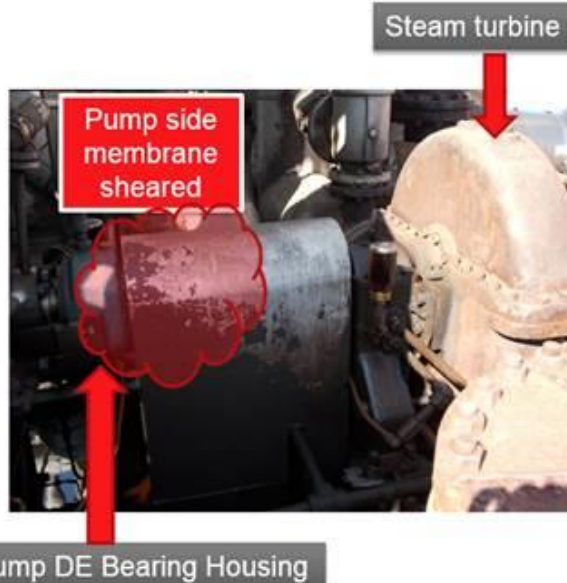
- **Failure Mode**

- The coupling failed at the Pump Drive end membrane – coupling failures of this nature are typically attributed to misalignment between driver and driven equipment
